## Silicon identification

This errata sheet applies to the revision A, Z, Y and X of STMicroelectronics STM32L062K8 microcontrollers.

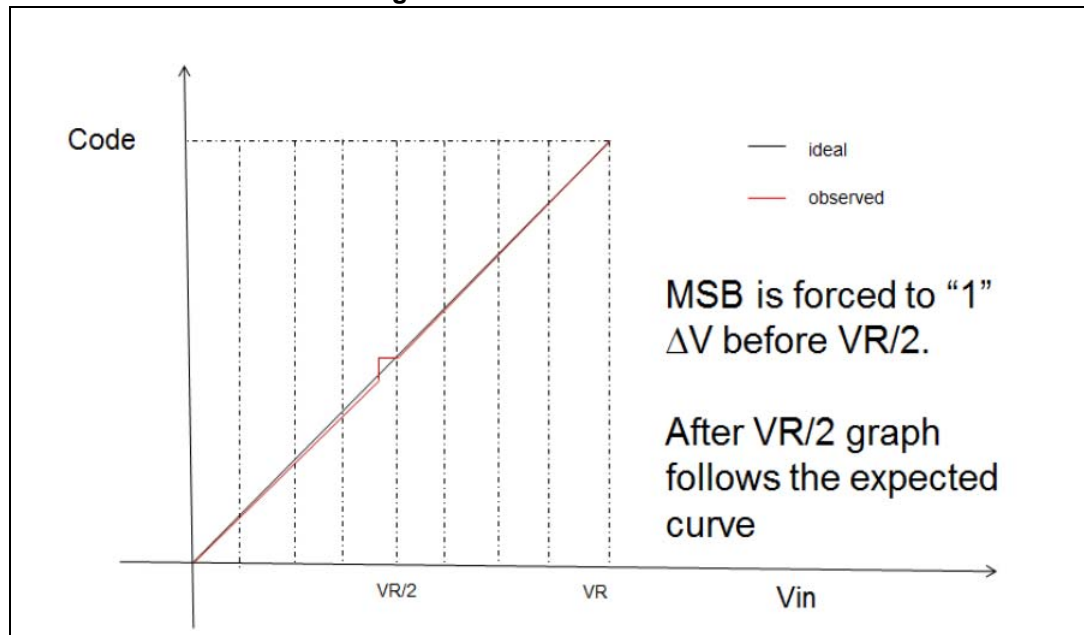
Figure 1. Data transfer curve

When  $V_{REF+}$  is lower than  $V_{DDA}$ , and only in this case, the data MSB is forced to '1' just before  $V_{IN}$  reaches  $V_{REF+}/2$ . As a result, the data transfer curve shows a discrepancy around  $V_{REF+}/2$  (see [Figure 1](#)).

*Note:* The transfer curve behaves as expected when  $V_{IN}$  is strictly lower or higher than  $V_{REF+}/2$ .
